Manhole Inspection Summary

Manhole # S41W1_017MH

Location Address: **622 Maude Ave.**

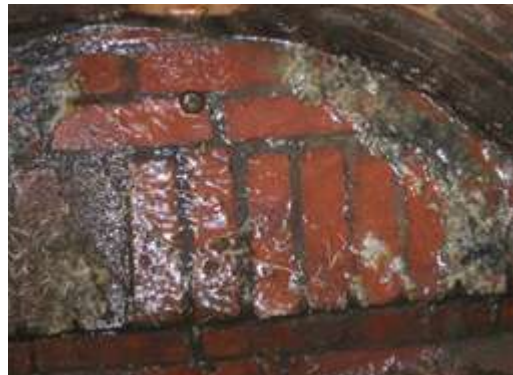
Defect 2

Condition: ☐ Sound ☐ Cracked ☐ Root Intrusion ☐ Deteriorated ☒ **Leaks** ☐ Debris

Pipe flowing onto bench w/ waste

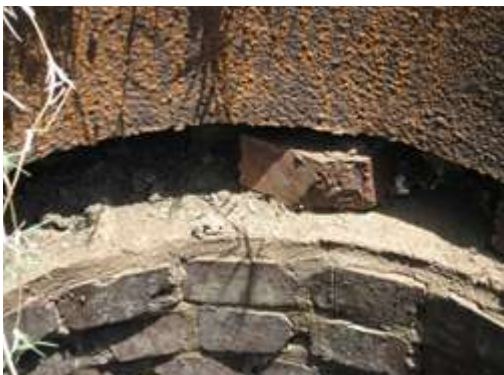
Defect 1

Condition: ☐ Sound ☐ Cracked ☐ Root Intrusion ☒ **Loose Brick** ☐ Deteriorated

Loose bricks in chimney

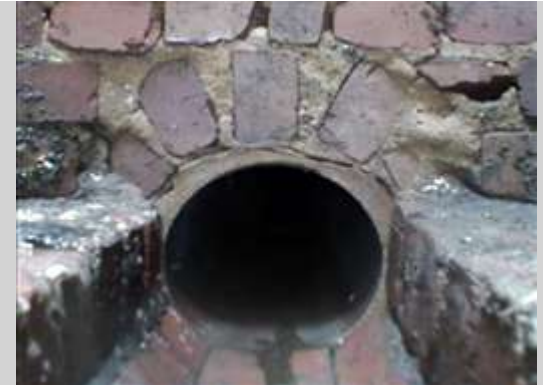
12 O'Clock Outflow

8 in. Circular Gravity Sewer
Pipe Out @ 12 O'Clock

Pipe Height: **8.4** (in.) Rod and Bar (Angled)
Pipe Material: **Clay** ☐ Pipe Lined
Invert Depth: **7.52** (ft.) Flow Characteristics: **Fast**
Deposits: ☒ None ☐ Mud ☐ Sludge ☐ Debris ☐ Grease
Silt Depth: (in.) Deposits Extent:
Infiltration: **None** Pipe Seal Cond: **Sound**

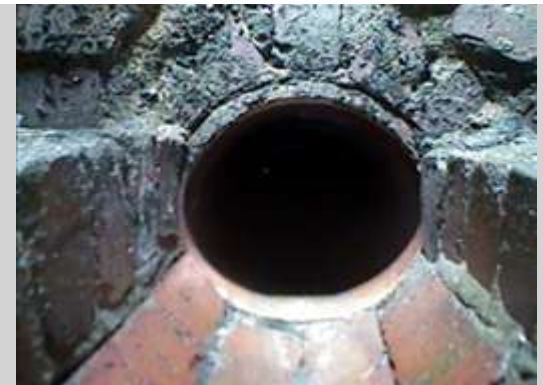
6 O'Clock Inflow

8 in. Circular Gravity Sewer
Pipe In @ 6 O'Clock

Pipe Height: **8.4** (in.) Rod and Bar (Angled)
Pipe Material: **Clay** ☐ Pipe Lined
Invert Depth: **7.20** (ft.) Flow Characteristics: **Fast**
Deposits: ☒ None ☐ Mud ☐ Sludge ☐ Debris ☐ Grease
Silt Depth: (in.) Deposits Extent:
Infiltration: **None** Pipe Seal Cond: **Sound**

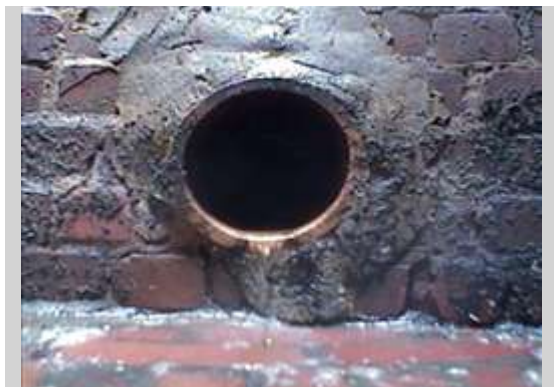
9 O'Clock Inflow

6 in. Circular Gravity Sewer
Pipe In @ 9 O'Clock

Pipe Height: **6** (in.) Rod and Bar (Angled)

Infiltration: **None**

Pipe Seal Cond: **Sound**
